# Pedestrian Crosswalk Research Study

Identifying Innovative & Feasible  
Pedestrian Crosswalk Technologies for  
Two Study Corridors in Volusia County

**GMB Engineers & Planners, Inc**  
2/23/2010

For  
S Atlantic Avenue from Dunlawton Avenue to Beach Street  
&  
CR A1A from E 6<sup>th</sup> Avenue to Canaveral National Seashore Entrance

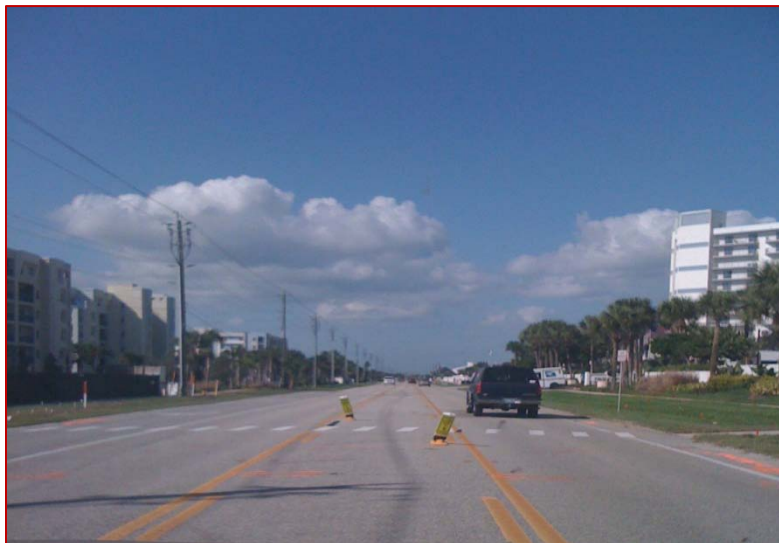
MUTCD R1-6 In-Street Pedestrian Crosswalk Signs are intended for use at uncontrolled (unsignalized) crosswalks to remind drivers of laws regarding pedestrians' right-of-way. The legend "State Law" may be shown on the top of the sign if applicable.

**Figure 3: Picture of In-Street Pedestrian Crosswalk Signs**

This technology is currently used in both the study areas. However, the size and number of signs used at an individual location are the two areas where improvements could be considered to improve the effectiveness of these signs. For instance, instead of one sign, a group of at-least three signs could be used to improve the effectiveness. The size of the sign could be increased for better visibility. Refer to the MUTCD – 2009 Edition and Section 3.8 of the Topic No. 750-000-005 on selection guidance and additional information on this treatment.

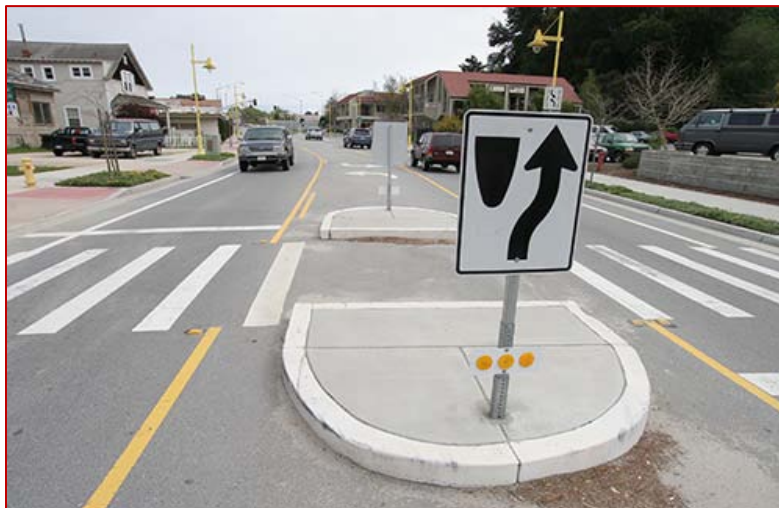
These are raised barriers in the center of the roadway (either in the median or center lane) that serve as a place of refuge for pedestrians who cross a street at mid-block or at an intersection. However, the turning movements have to be carefully planned so that

**Figure 4: Picture of a Median Refuge Island**

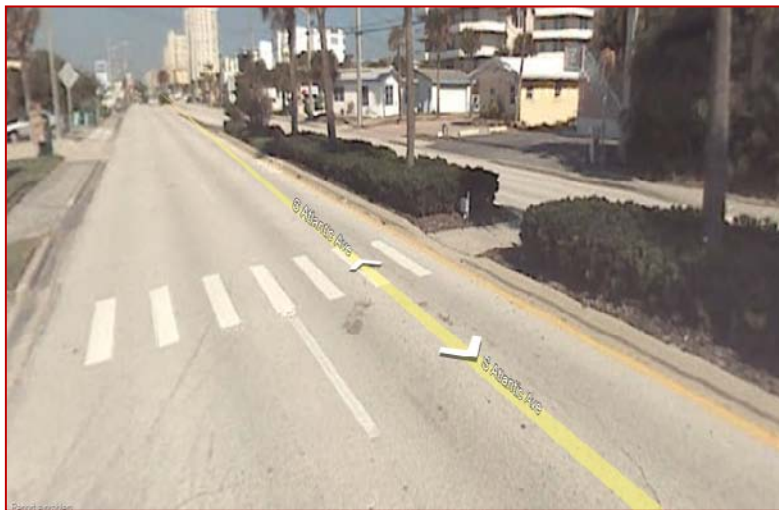
**Figure 5: Picture of a Median Refuge Island on S Atlantic Avenue between Dahlia Avenue and Phyllis Avenue (source: Google Maps)**

This technology is currently used in Study Area 1 near Dunlawton Avenue on S Atlantic Avenue as shown in Figure 5. However, the technology could be tested at other multilane crosswalk locations in the two study areas, as recommended for consideration in Section 3.8 of the Topic No. 750-000-005.

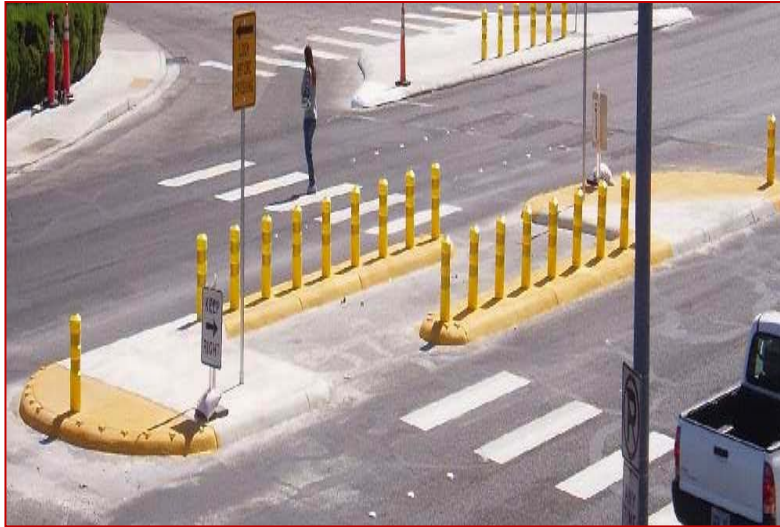
A Danish offset is an offset at the middle of a multilane crossing that provides refuge for pedestrians in terms of physical separation from traffic and ensures they are facing the traffic before crossing the second half of the roadway.

**Figure 6: Picture of Danish Offset and Median Refuge Island Combination**

The offset is a type of channelization that encourages pedestrians to turn and walk parallel to the traffic they are crossing.

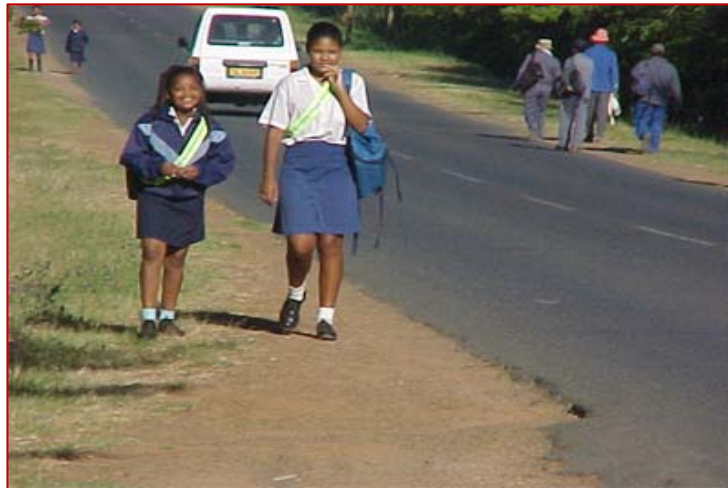
These low cost retro-reflective materials could be distributed to pedestrians that frequently use the study area crosswalks. These materials are especially helpful to children and senior citizens. Various materials were identified to be effective including clipsters, zipper pulls, badges and armbands.

**Figure 7: Picture of a Retro-reflective Material used by School Children**

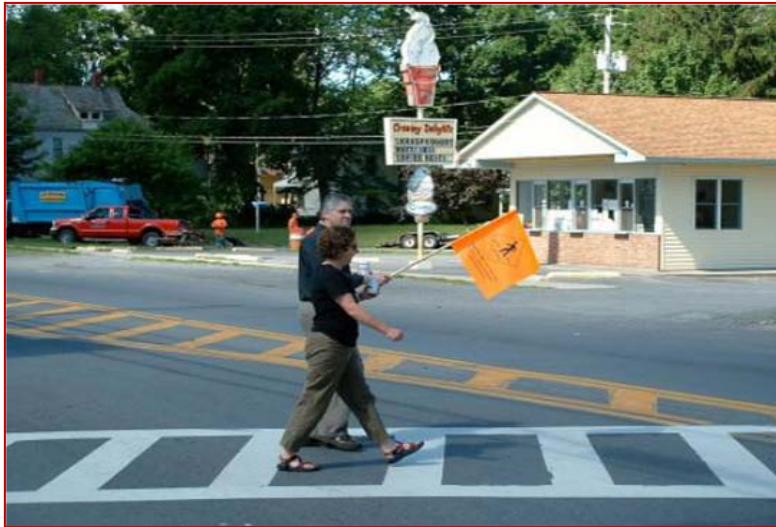
These low cost crosswalk flags are provided to pedestrians at the crossing. This technology is currently used in Hudson Falls, New York. This technology has all the advantages of the retro-reflective material.

The concerns with this technology are 1) to encourage pedestrians to use the flags for crossing and 2) to replace the stolen flags at crossing locations at regular intervals. Collector bins are generally provided at either end of the crosswalks as a storage space for the flags.

**Figure 8: Picture of a Crossing Flag (Hudson Falls, New York)**

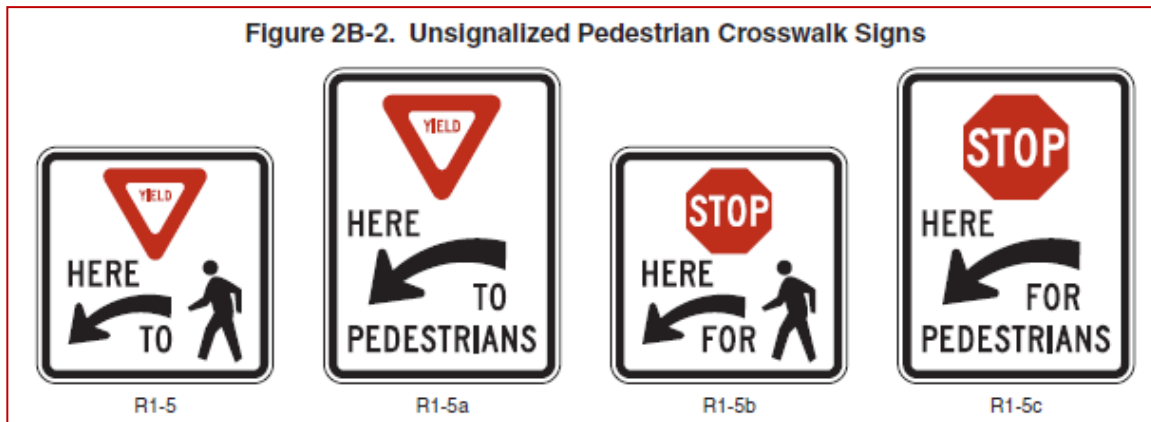
Another low cost and effective crosswalk technology is the use of R1-5 series crosswalk signs at uncontrolled crosswalks on multi-lane approaches. The MUTCD – 2009 Edition and Section 3.8 of the Topic No. 750-000-005 provides additional information on the use of R1-5 series crosswalk signs.

The MUTCD states that these signs shall be used if yield or stop lines are used in advance of a marked crosswalk that crosses an uncontrolled multi-lane approach. These signs should be placed 20 to 50 feet in advance of the nearest crosswalk. According to the Section 3.8 of the Topic No. 750-000-005, R1-5 series shall not be used in combination with Rectangular Rapid Flashing Beacons (RRFB) Assembly or flashing beacons, In-Roadway Lighting, a Pedestrian Hybrid Beacon or traffic signal.

**Figure 9: Picture of R1-5 Series Crosswalk Signs (source: MUTCD 2009 Edition)**

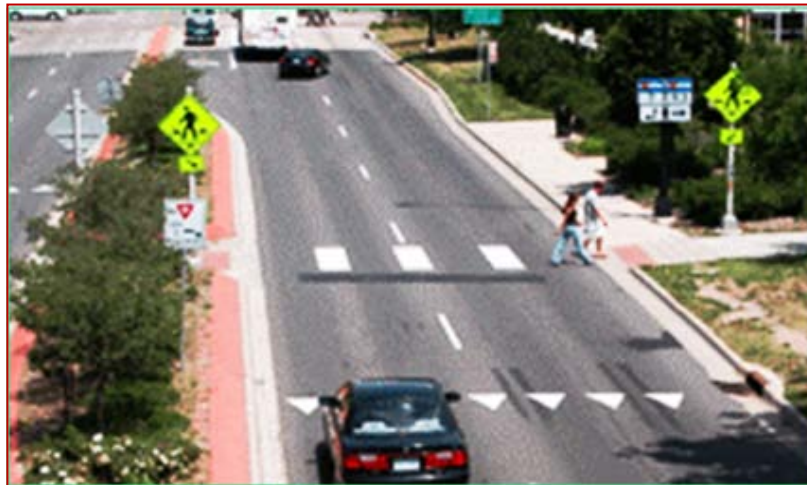
**Figure 10: Picture of R1-5a Crosswalk Sign in combination with Yield Lines (source: [http://www.bouldercolorado.gov/index.php?option=com\\_content&view=article&id=963&Itemid=3625](http://www.bouldercolorado.gov/index.php?option=com_content&view=article&id=963&Itemid=3625))**

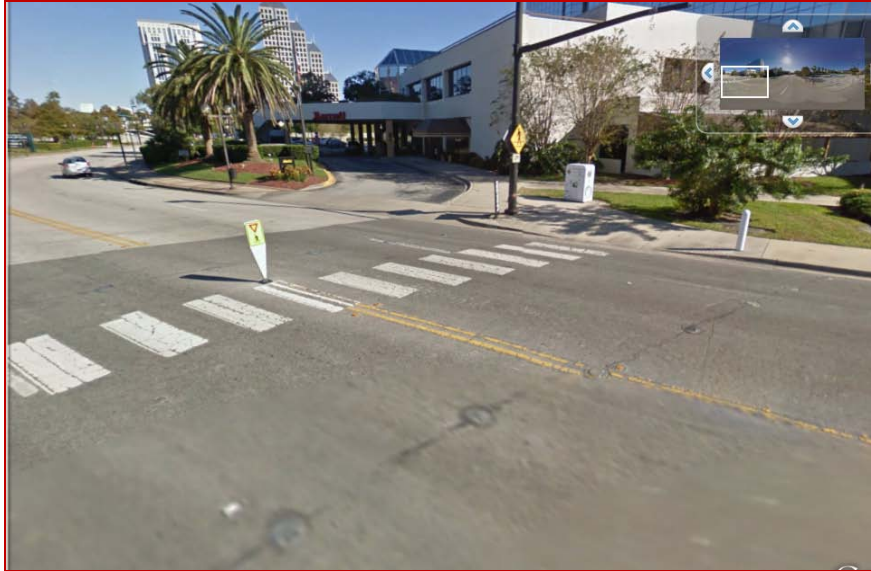
In-pavement lights are being used at crosswalks to alert motorists to the presence of a pedestrian crossing or pedestrians preparing to cross the street. The amber lights are embedded in the pavement on both sides of the crosswalk and oriented to face oncoming traffic.

When the pedestrian activates the system, either by using a push-button or through detection from an automated device, the lights begin to flash at a constant rate, warning the motorist that a pedestrian is in the vicinity of the crosswalk ahead.

**Figure 11: Picture of In-Pavement Lighting on Livingston Street in Orlando (source: Google Maps)**

The amber LED lights flash in unison at a rate designed for maximum motorist recognition and are visible during the daylight as well as at night. The flashing lights are only activated when a pedestrian wants to cross and are automatically shut off after a set period of time, i.e., the time required for a pedestrian to safely cross the street. If installed in conjunction with the means to detect the presence of pedestrians while in the crosswalk, the crossing interval can be extended, in which case the lights would continue to flash and allow slower pedestrians to safely cross.

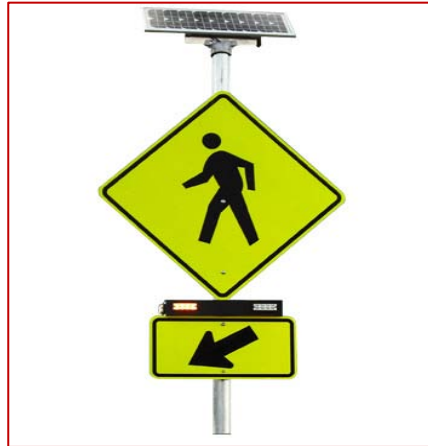
These flashing beacons are generally provided in pairs below the pedestrian crosswalk sign (W11-2) and operate in a wig-wag pattern.

The RRFB remains dark until a pedestrian activates the system by pressing a pushbutton. Once the system is activated, rapidly flashing amber beacon lights provide a bright warning to motorists.

**Figure 13: Picture of RRFB (source: 4)**

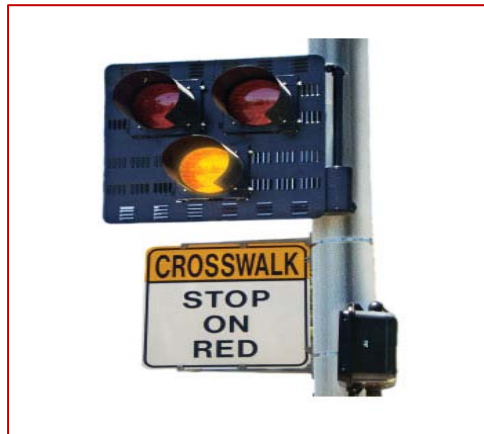
HAWK beacons could be installed on roadside poles and mast arms and remains dark until a pedestrian activates the system by pressing a pushbutton. Once the system is activated, a sequence of amber and red beacon lights provides a bright warning to motorists.

The system also provides a Pedestrian Signal Head and could be used as mid-block pedestrian signal.

**Figure 14: Picture of HAWK Beacon (source: 4)**
